**REPORT**  
**OF**  
**THE COURT INVESTIGATING**

**ACCIDENT TO AIR INDIA**  
**BOEING 747 AIRCRAFT VT-EFO,**  
**“KANISHKA”**  
**ON 23<sup>RD</sup> JUNE 1985**

**FEBRUARY 26, 1986**

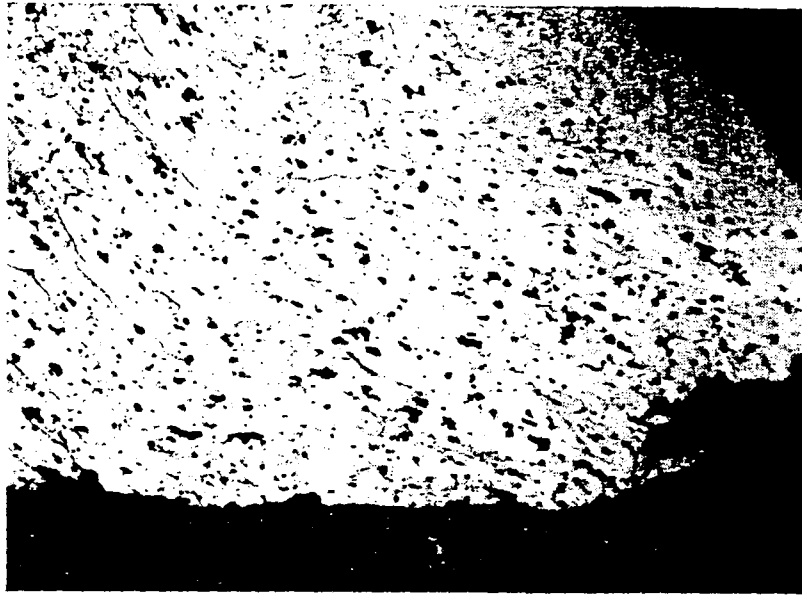
3.2.11.35 A portion of the skin containing part of hole No. 14 was cut, polished on the thickness side of the skin and examined in a metallurgical microscope. Fig. 362-24 shows the microstructure of this region. The flow of metal along the edge of the hole can be seen from the shape of the deformed grains near the hole. This can be compared with the bulk of the grains shown in Fig. 362-25, away from the hole. In addition, in Fig. 362-24, a series of twin bands can be seen in some of the grains near the hole. Fig. 362-26 shows these bands at a higher magnification. Normal deformation rates at various temperatures do not produce such twinning in aluminium or its alloys. It may be noted that this microstructural feature is absent in the microstructure of the skin, away from hole No. 14, Fig. 362-25.

Fig. 362-24. Microstructure of the inner surface of hole no.14, showing twin bands. Keller's etch. 150 X.

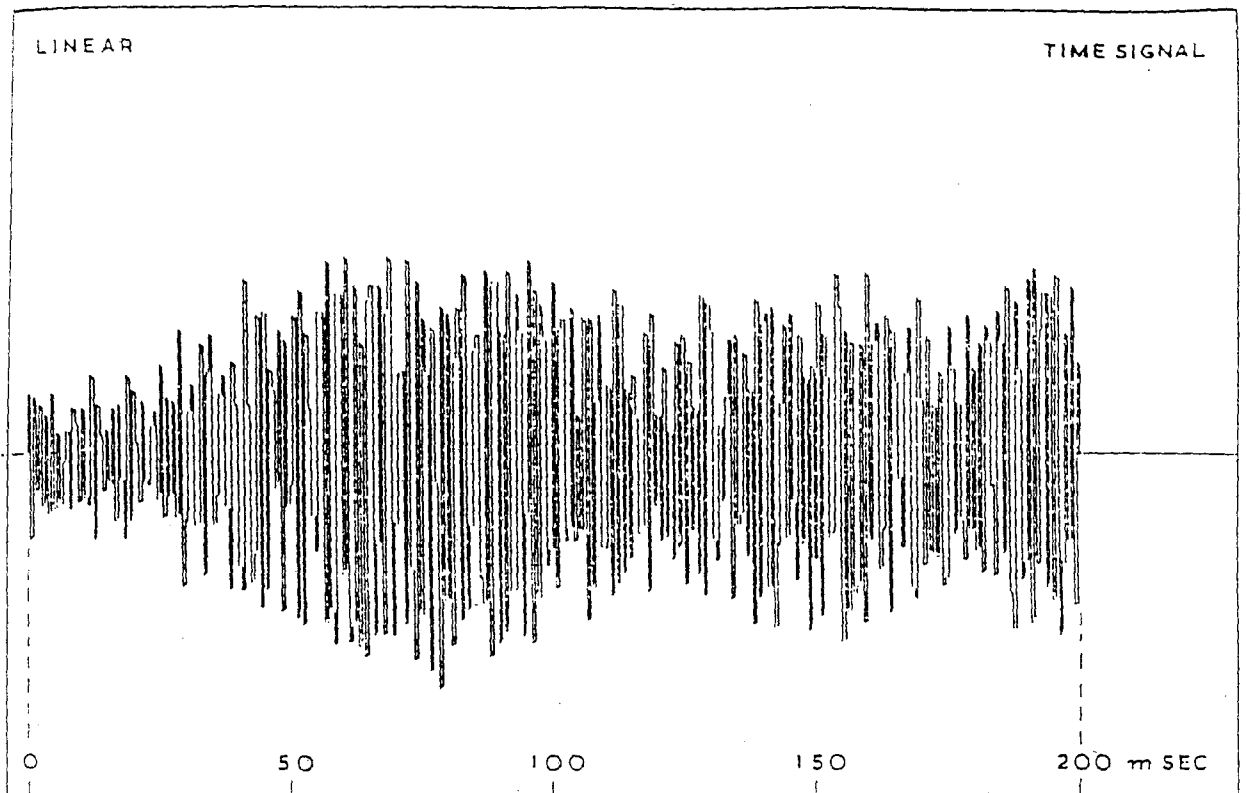
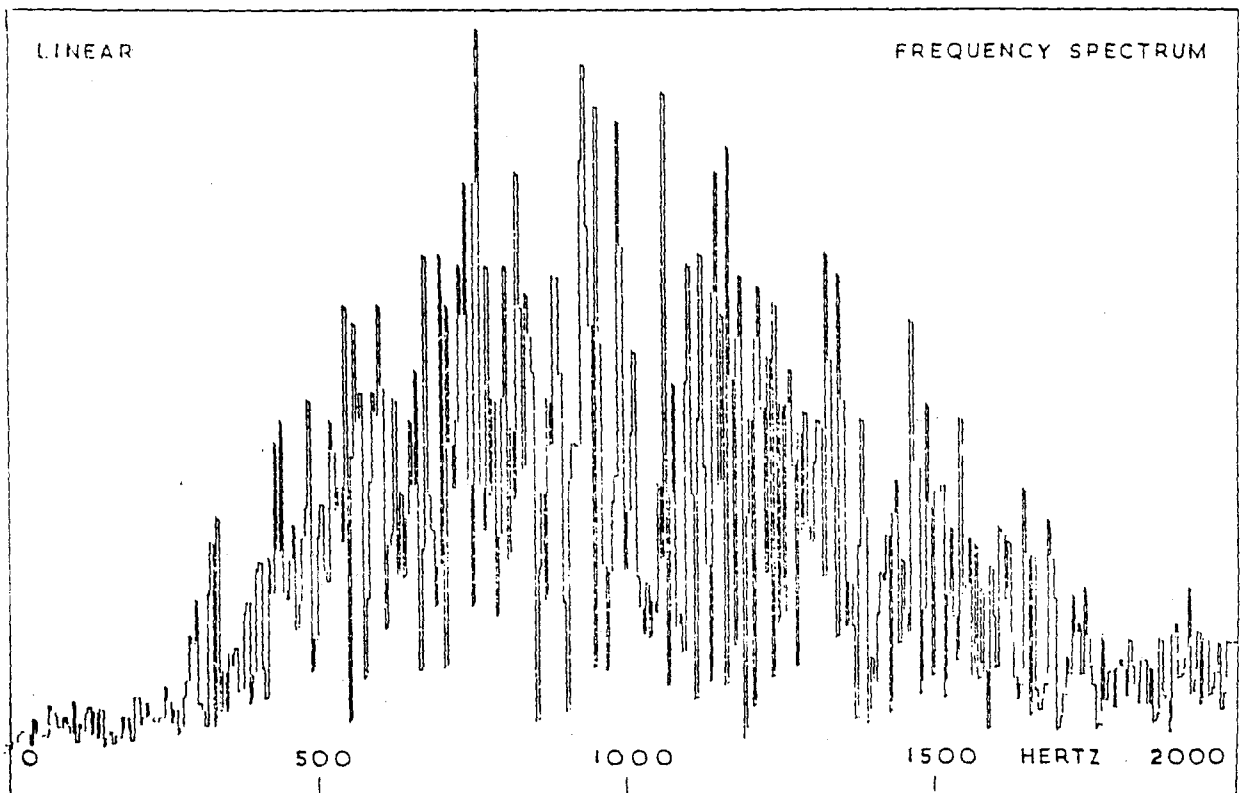
CHANNEL 3: AT BANG

Fig. 3 : KANISHKA -- Time Signal and Frequency Spectrum of CAM Channel at 'bang'.

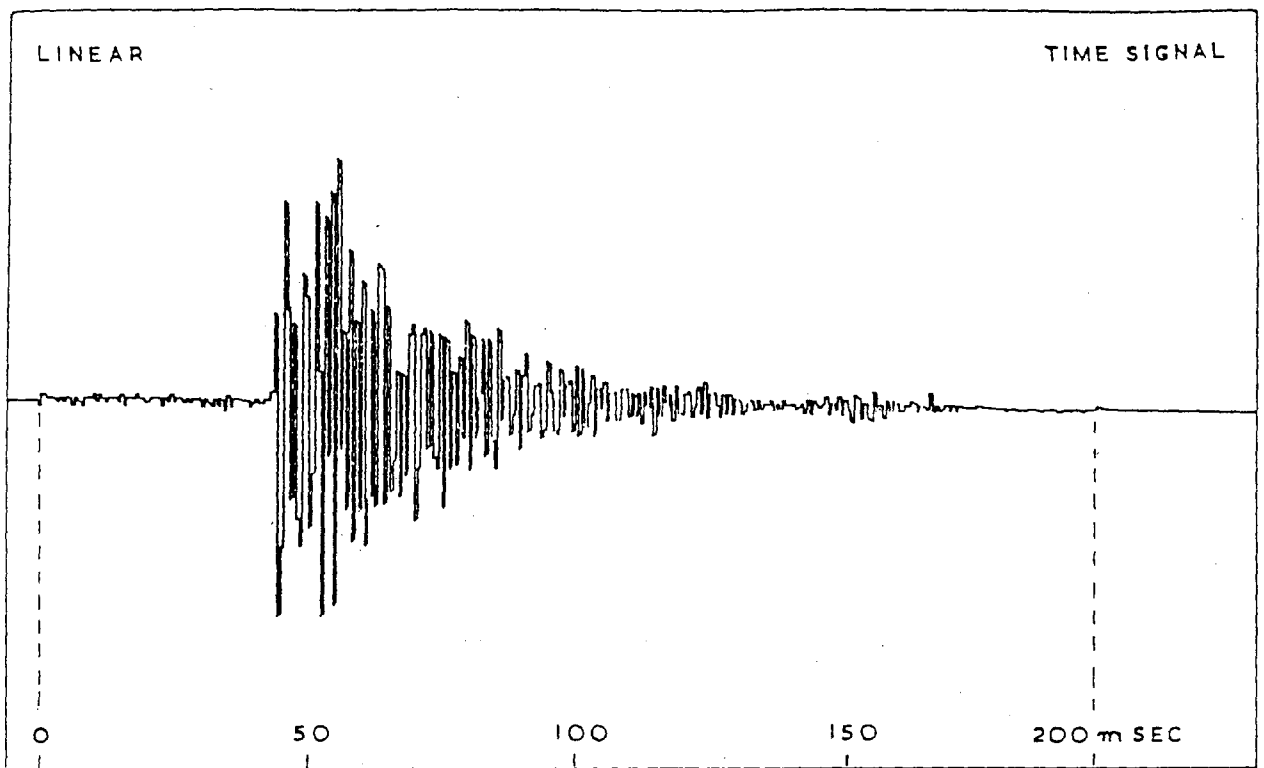
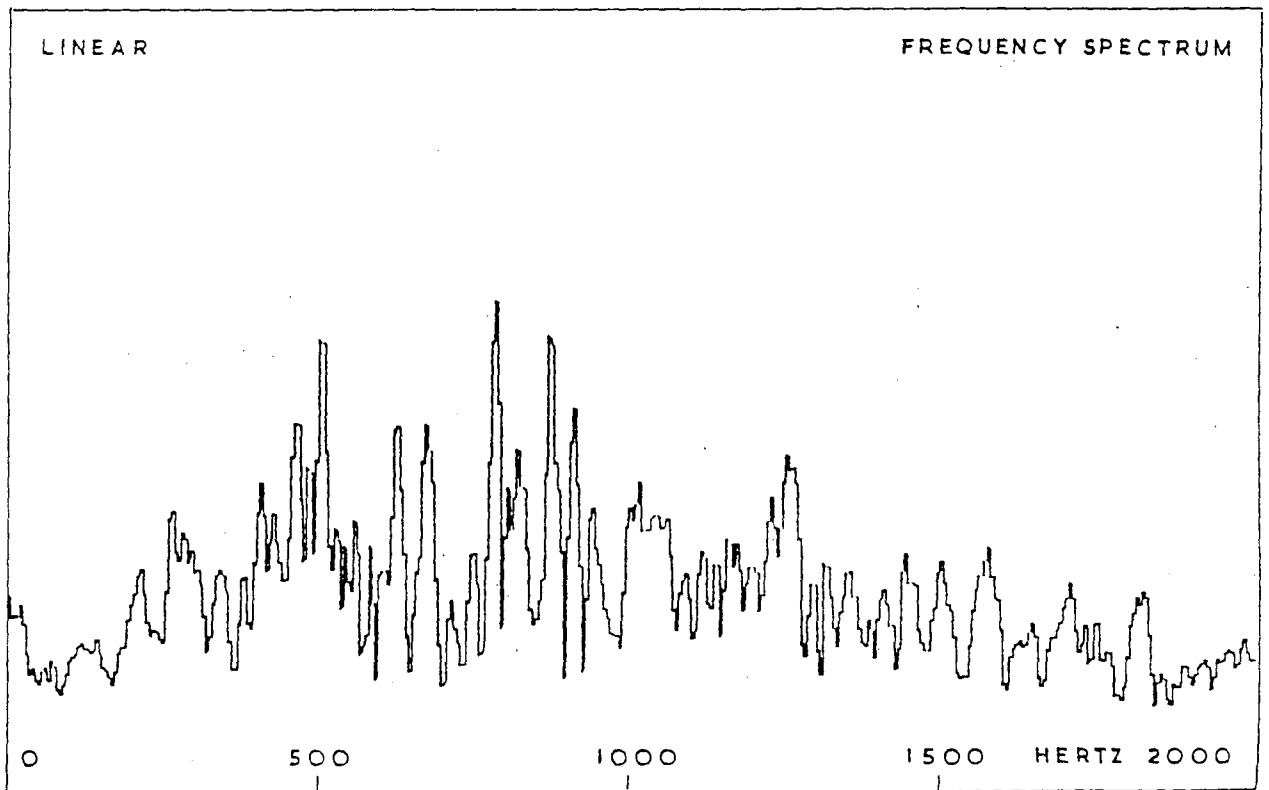
IA BOEING 737  
CHANNEL 3 : AT BANG

Fig. 4 : Indian Airlines B 737 — Time Signal and Frequency Spectrum of CAM Channel at 'bang'.
